Summers, L. & Maddrell, R. J. 1978

Barton-on-Sea: Development of an Alternative Approach to Coast Protection.

Paper presented to the Geological Society Engineering Group regional meeting at Southampton University, September 1978.

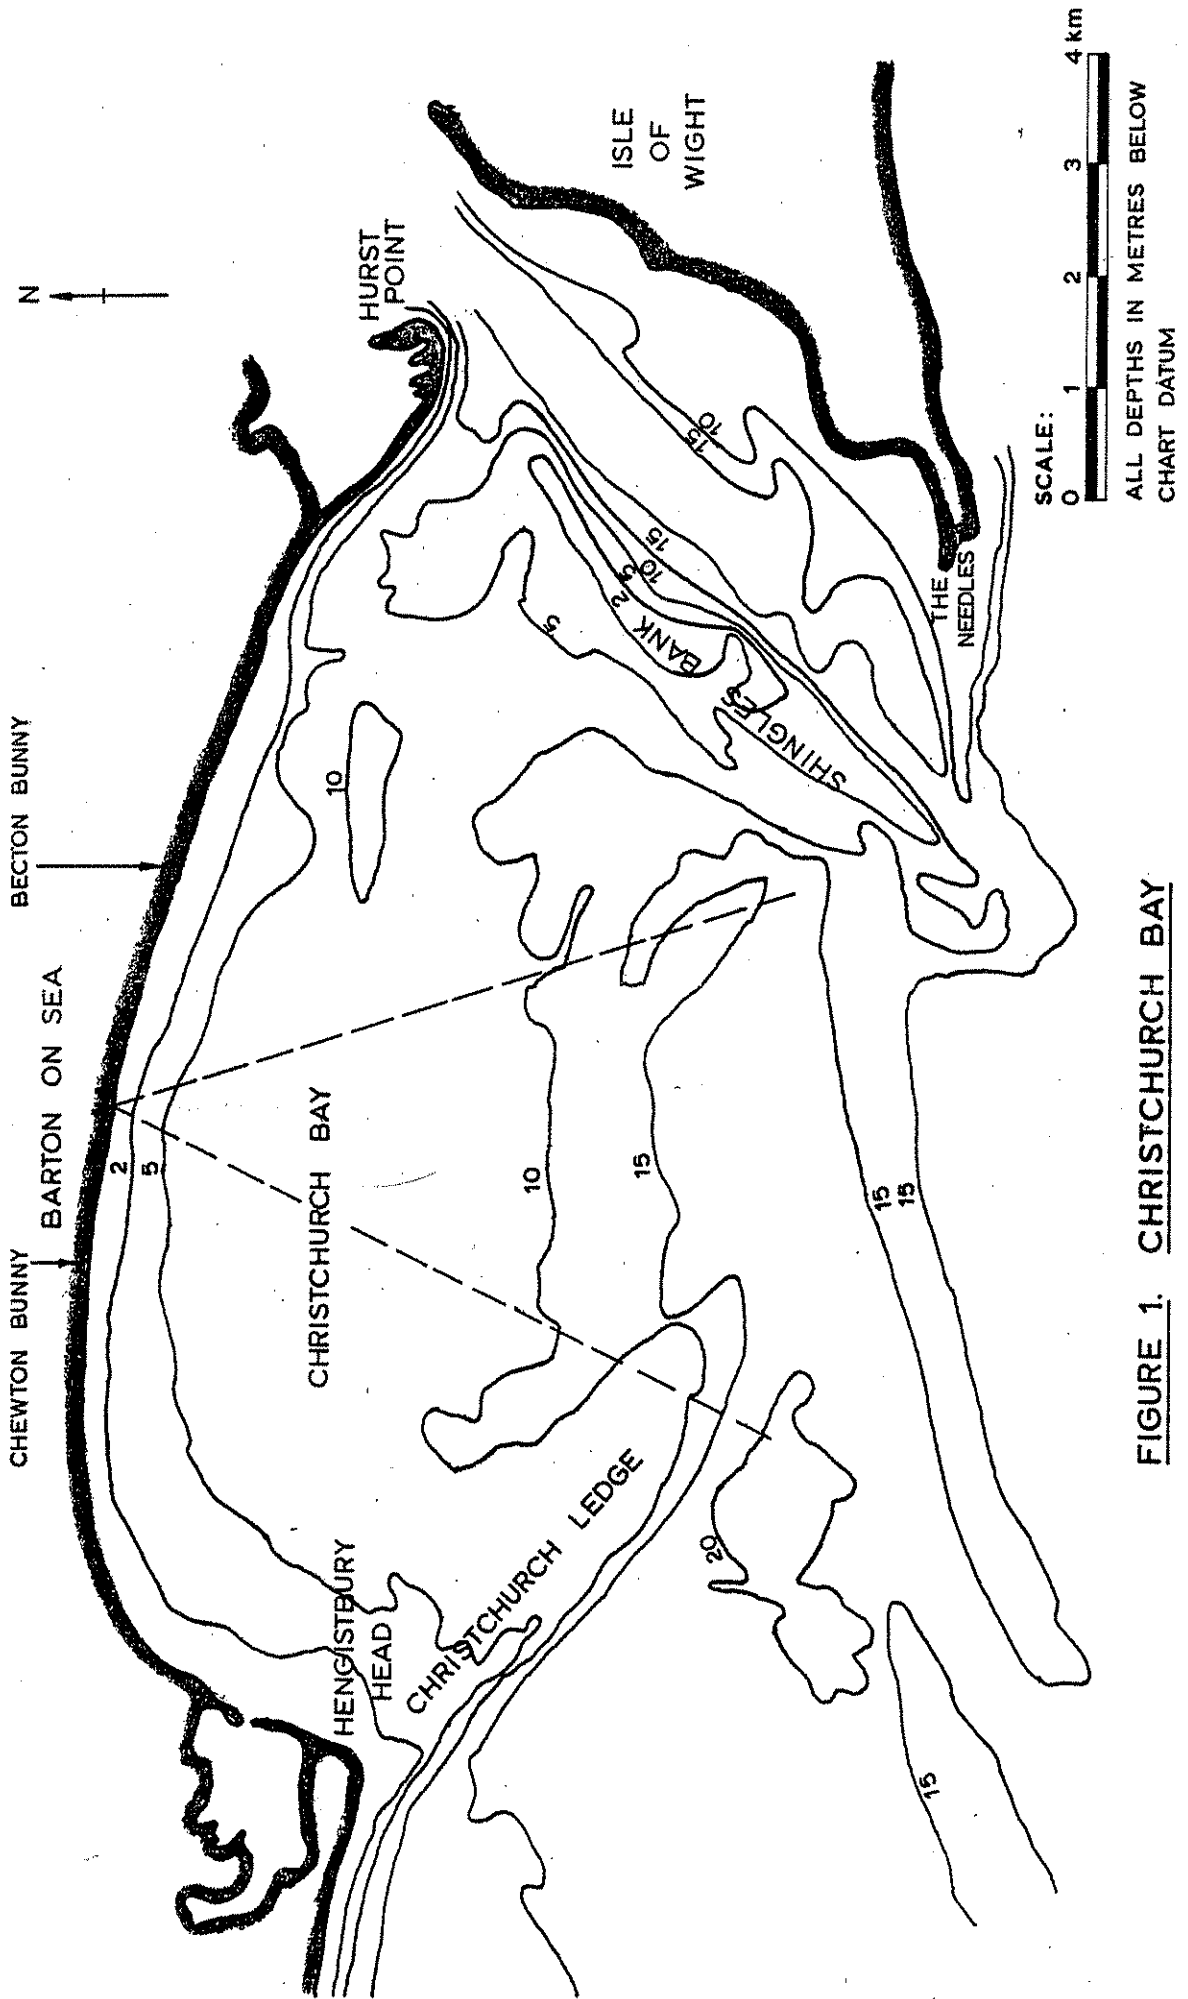
**FIGURE 1. CHRISTCHURCH BAY**

Considering now the seaward topography in Christchurch Bay, this is contained between the apparently stable features of Hengistbury Head at the west end and Hurst Spit at the east end, both of which extend well out below low water in the form of elongated banks, as shown in Figure 1. To the west Christchurch Ledge extends some 5 km SE from the Head to a depth of some 6 m below Datum and to the east the Shingles Bank extends some 6 km SSW from Hurst Bank at a shallower depth along the NW side of the Needles Channel. These underwater features act as submerged offshore breakwaters, protecting the Barton frontage from the larger storm waves generated from SSW to W and from SE.

Between the ends of these features, a distance of some 5 km, the bed depths reach 15 to 20 m below datum and this gap allows full storm waves, of 6 to 8 m height, to approach the Barton frontage directly over an arc of some  $45^{\circ}$ , from the SSW to SSE. Waves of 4 m or greater crossing either bank become unstable and tend to break, while smaller waves are shortened and steepened on passing over the banks. The tidal range of mean spring tides is about 2.2 m, and that of the highest and lowest astronomical tides is about 3.3 m, being the

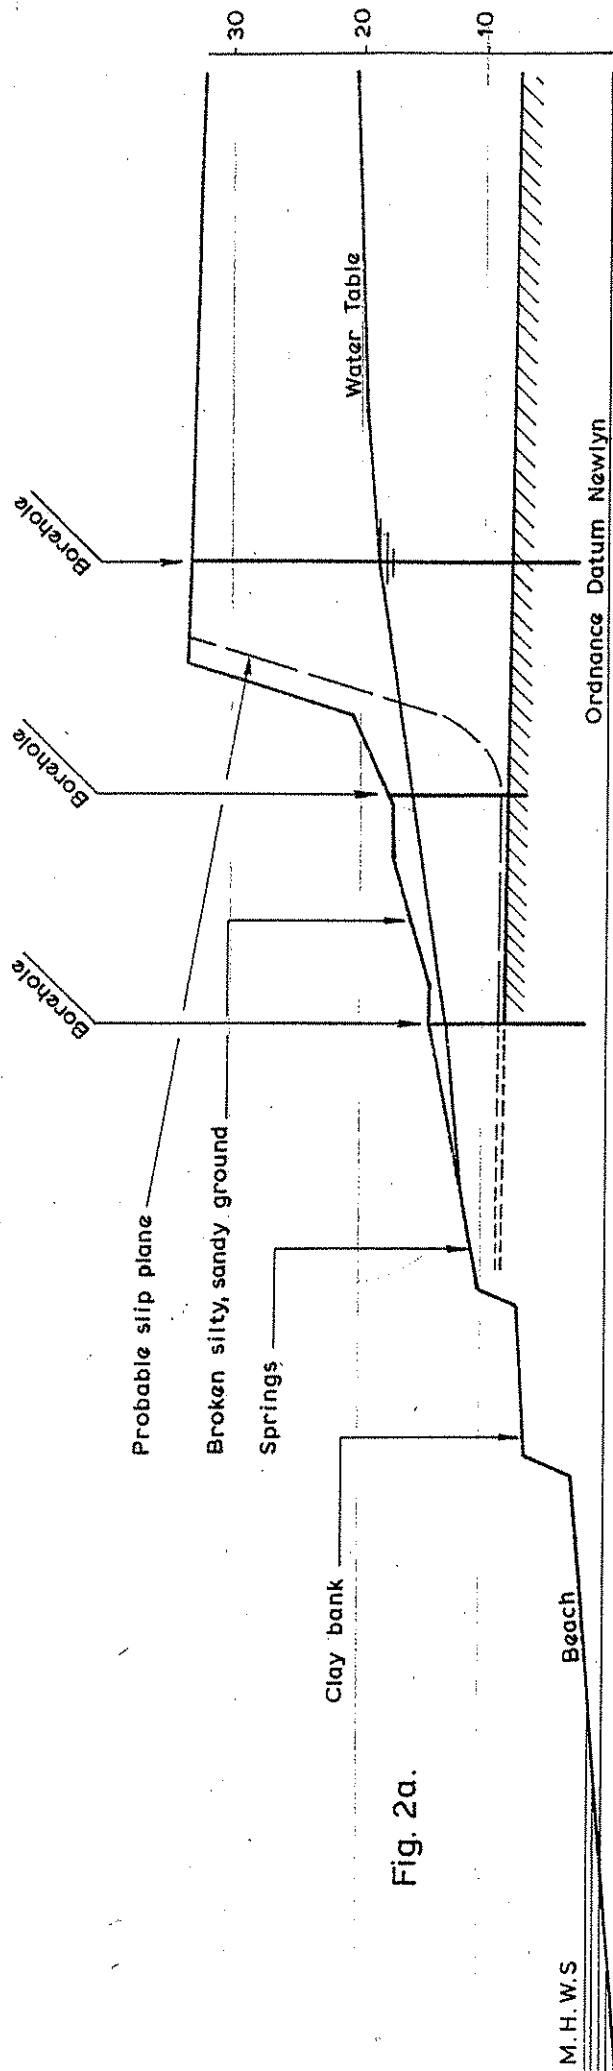
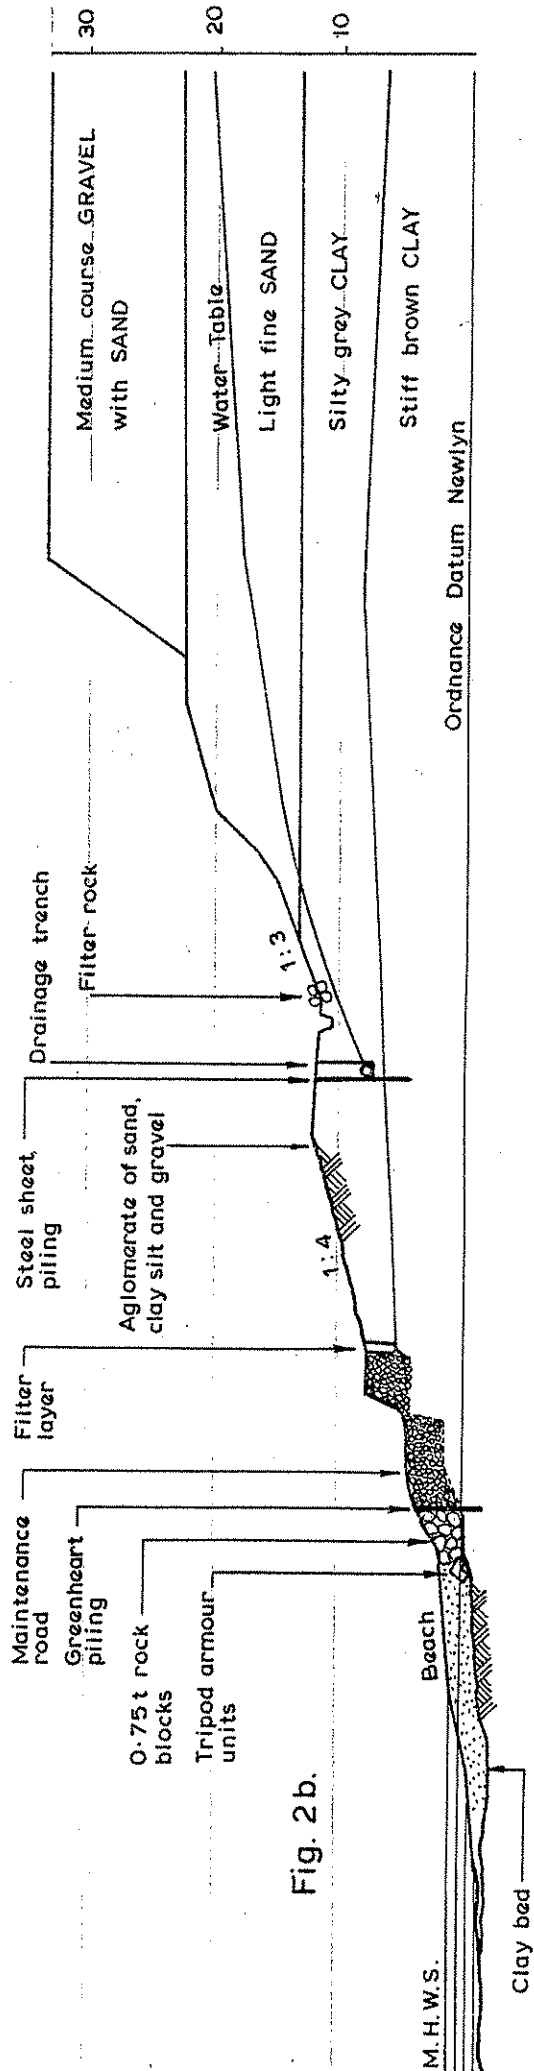
FIGURE 2. CROSS SECTIONS OF FORESHORE AT BARTON-ON-SEA a) 1960 b) 1978

The landward topography at Barton consists of a fairly level plateau at an average height of about 35 m above Ordnance Datum (approximately Mean Sea Level), fronted by a steep cliff below which lies an undercliff area of broken ground extending for about 70 m out to the foreshore. The toe of the natural undercliff is formed of a clay bank, exposed to wave action in storms and at high tides, then several flat terraces which tend to pond water, with intermediate clay banks and, beyond, a water-logged broken silty-sandy stretch of ground rising at a slope of about 1 in 3 to the foot of a steep cliff of terrace gravels. Figure 1 shows a plan of Christchurch Bay and Figure 2 (a) is a typical cross-section of the cliff and foreshore as it was in 1960.

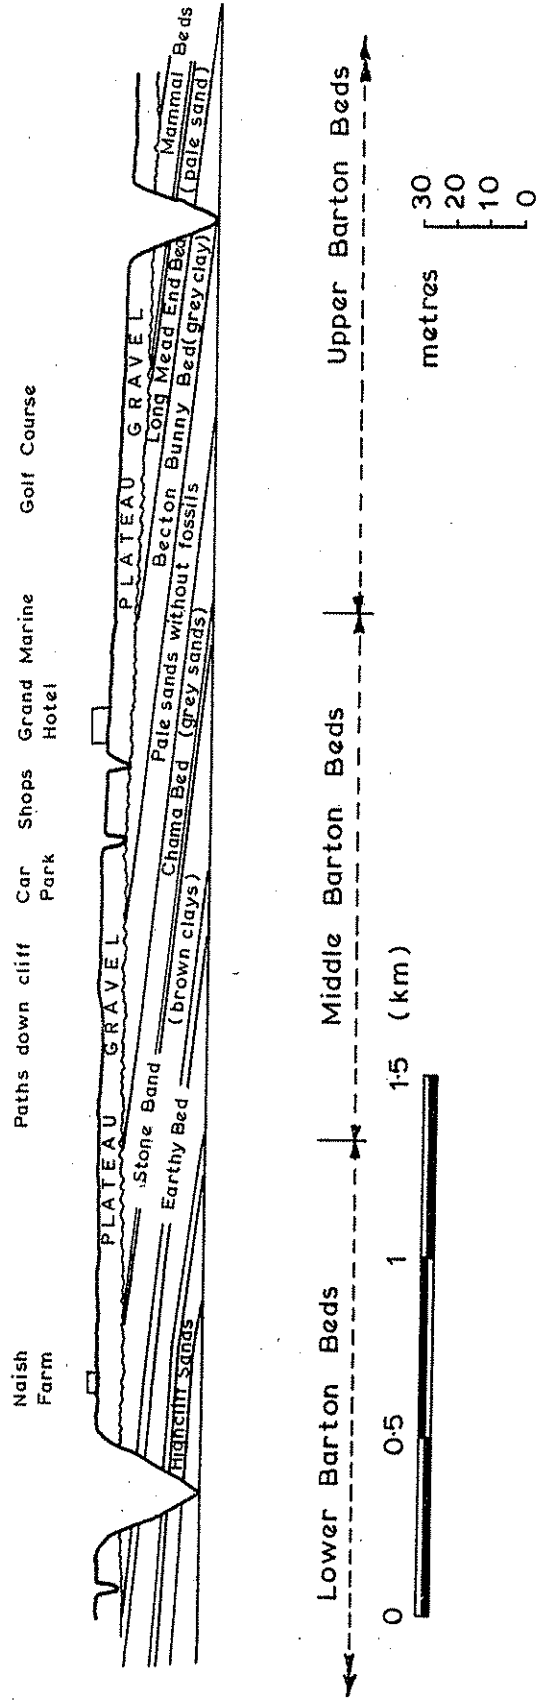
FIGURE 3. GEOLOGICAL ELEVATION THROUGH CLIFF AT BARTON

The geological structure of the ground, shown in Figure 3, is one in which a capping of open plateau gravel rests unconformably on semi-permeable silty sands of the Upper Barton Beds which in turn overlie

the impermeable silty clays of the Middle Barton Beds. The beds dip towards the east at a variable slope, but averaging 1 in 80. Thus the top of the undisturbed Middle Barton clay stands at about 30 m above Ordnance Datum near the western Barton boundary on the line of the Walkford Brook in Chewton Bunny and drops to about 15 m below Ordnance Datum 3.5 km to the east, at the point where the stream in Beckton Bunny flows into the sea.

Groundwater in the Barton sands is perched above the clay and although it generally drains inland following the strata dip, it does also emerge as springs on the undercliff. The waterlogged material resulting from this flow causes clay slumps and mud flows towards the sea. This reduces support for the gravel cliff face and results in periodic massive cliff falls which gradually subside to become mixed with the flows. This material on reaching the foreshore is easily distributed by waves, the finest particulates being carried offshore, the sand and fine gravels oscillating in and out of the tidal range as littoral drift, and only the very coarse material remains on the beach throughout the winter.

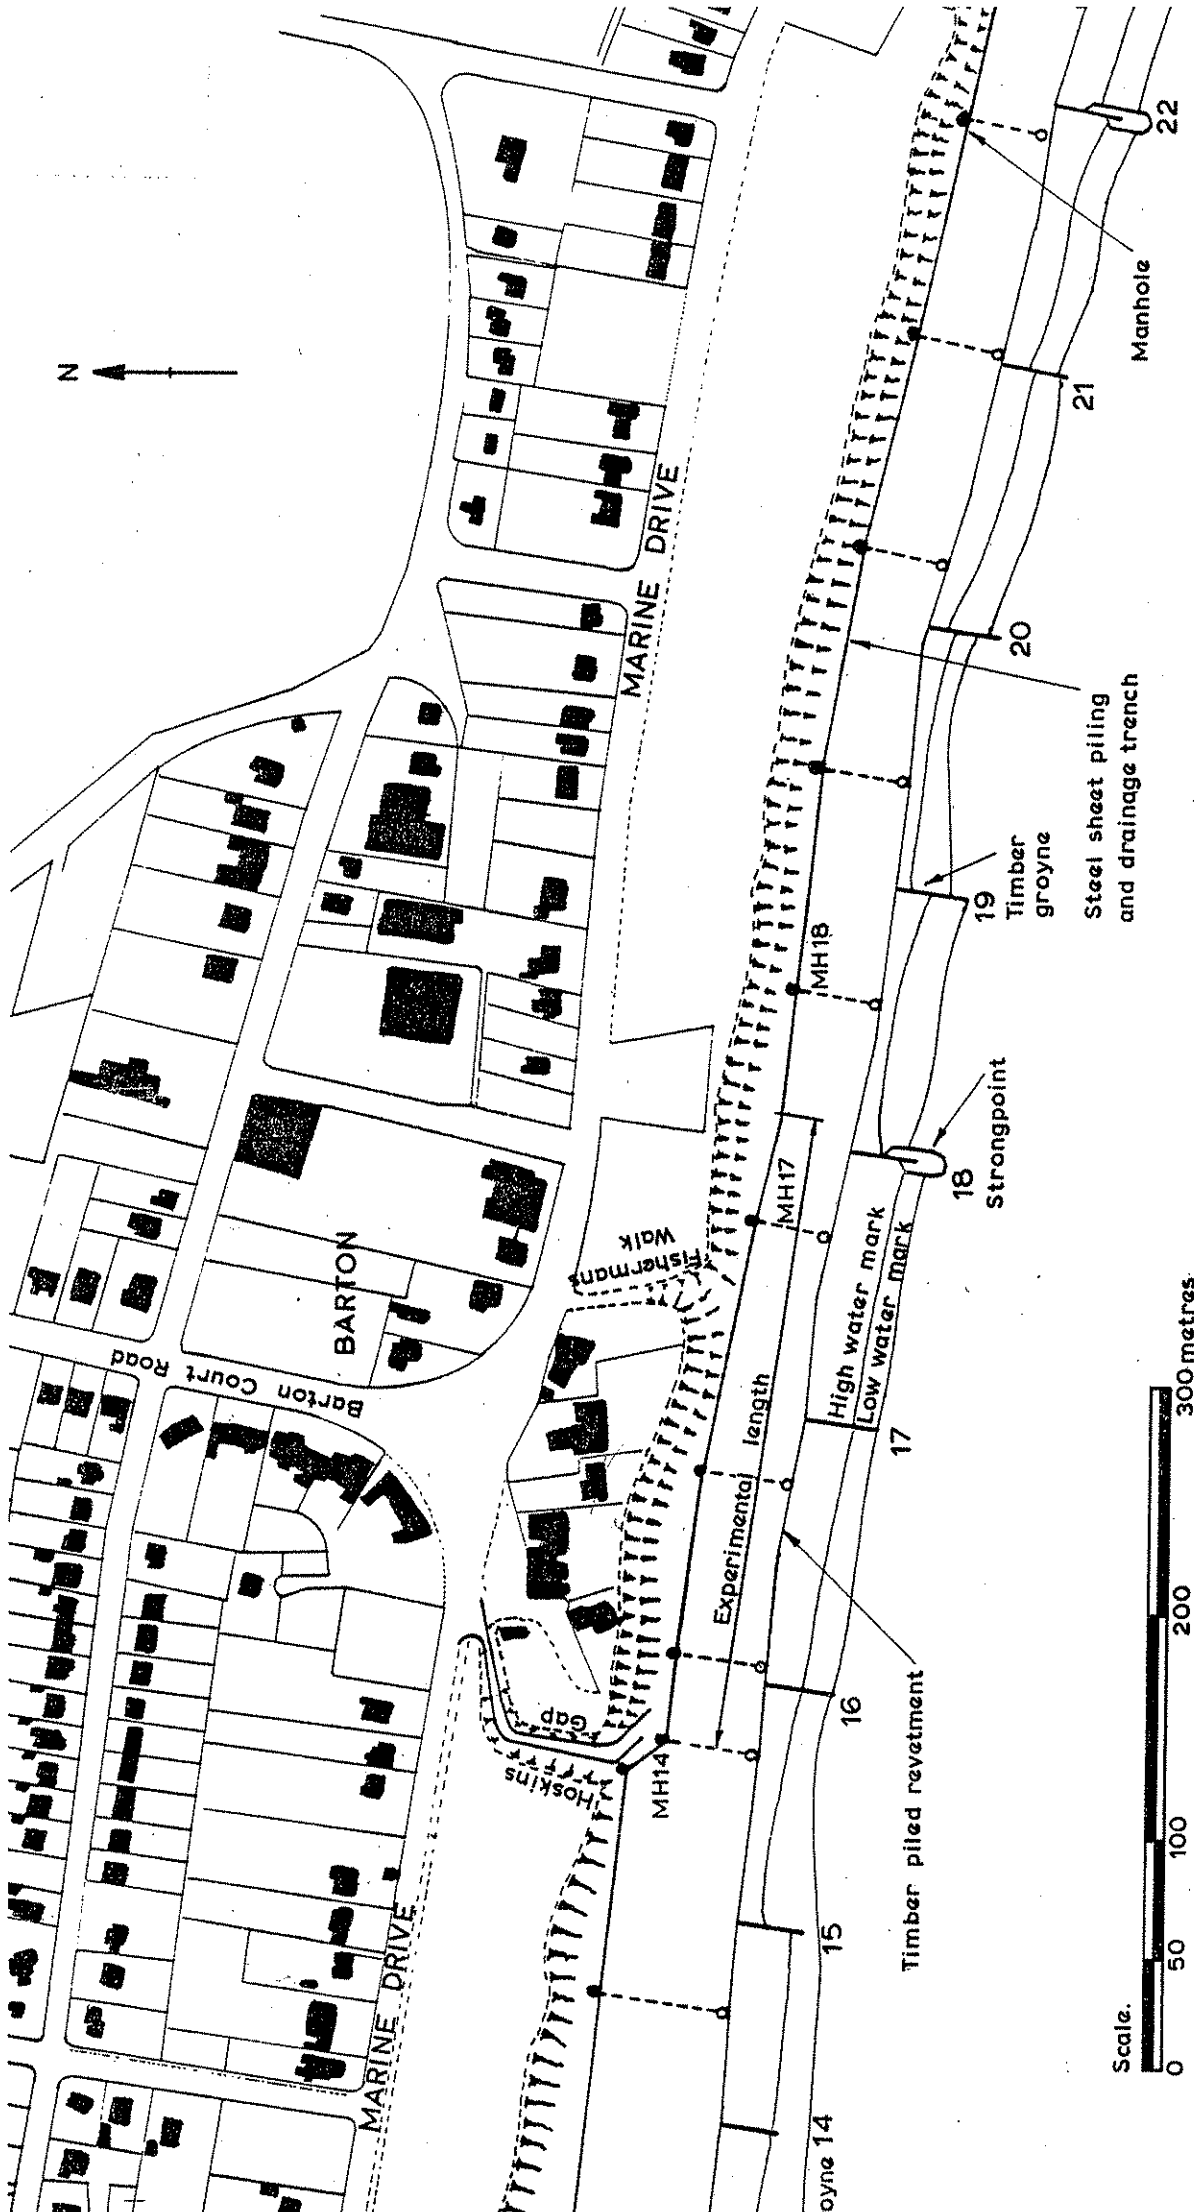
FIGURE 4. CENTRAL BARTON - REMEDIAL WORKS.

A report in August 1965 on the effectiveness of this experimental length noted the adverse effect of having to site the filter drain further forward from the gravel cliff than had been recommended due to the extent of boundaries of private properties on the undercliff. This resulted in the seaward slope of the cliff being at the limit of stability, even

when drained, and shallow slips occurred which ruptured the outlet pipes. However, within parameters that could then be fairly well defined, the scheme was shown to be successful.

A series of tests initiated in 1970 to monitor the performance of the works confirmed that between Hoskins Gap and Fisherman's Walk the filter drain was maintaining the water table at a level some 3 m below ground level behind the steel sheet pile cut-off, but a well established, almost horizontal, bench plane of sliding existed some 5 m below the top of the piling. In this area the very sensitive Chama silts and fine sands have their maximum depth in the cliffs immediately beneath the terrace gravels and consequently the steel sheet piled diaphragm is subjected to the maximum pressure from saturated soils. Even if a slope of well drained soil can be maintained seaward of the diaphragm at a maximum slope of 1 in 3, the factor of safety of the large volume of material above the plane of sliding is not much greater than unity. If this soil becomes damp with prolonged rainfall consequential surface slides can lower the factor of safety to slightly below unity. Further, if this situation is allowed to persist the diaphragm gradually loses support and moves forward at an increasing rate.

The mechanics of the cliff instability were first described in a report dated 1960 and alternative stabilisation schemes were recommended. One of these incorporated filter wells some distance landward of the cliff top, and another a steel sheet piled diaphragm backed by a filter drain on the undercliff. It was appreciated that there was unlikely to be a once and for all solution but the second scheme was considered to provide the best chances of bringing the mud flows under control. However, before proceeding with a full scheme, it was decided to construct an experimental length of works (Stage 1) in 1964 consisting of 300 m of filter drain, half with and half without a steel sheet piled diaphragm, three drainage outfalls together with four groynes without intermediate revetment. This experimental length was from west of Hoskins Gap (Manhole 14) to east of Fisherman's Walk (mid way between Manholes 17 and 18), as shown in Figure 4.

The main works were eventually constructed in 1967/68 including 16 timber groynes and a rock fill and timber revetment along 1.8 km of coast. By this time the toe of the undercliff had receded yet further along the experimental length and dry rock walls were provided landward of the revetment maintenance berm, as shown in Figure 2b, in an effort to reduce the undercliff slope and so achieve better stability. Despite these efforts, however, the undercliff remained sensitive to persistent rainfall.

Maintenance works, therefore, were concentrated upon improving the surface drainage of the undercliff to prevent such superficial slips. In addition the slope providing passive resistance in front of the diaphragm was extended, by placing 0.75 tonne rock blocks seaward of the timber revetment, down to sea bed level as illustrated in Figure 2b. A substantial rock splash wall was also provided landward of the revetment maintenance road to enable the slope in the Chama silts to be flattened off to 1 in 4. Additional rock fill counterfort drains were installed to increase the rate of surface drainage. It was later found to be necessary to place a row of concrete Tripod armour units at the toe of the rock slope to prevent breaking storm waves drawing the rock seaward.
