Lessons Re-Learnt from the Failure of Marine Structures

Dr Roger Maddrell, Consultant, Halcrow Group Ltd, Swindon, UK

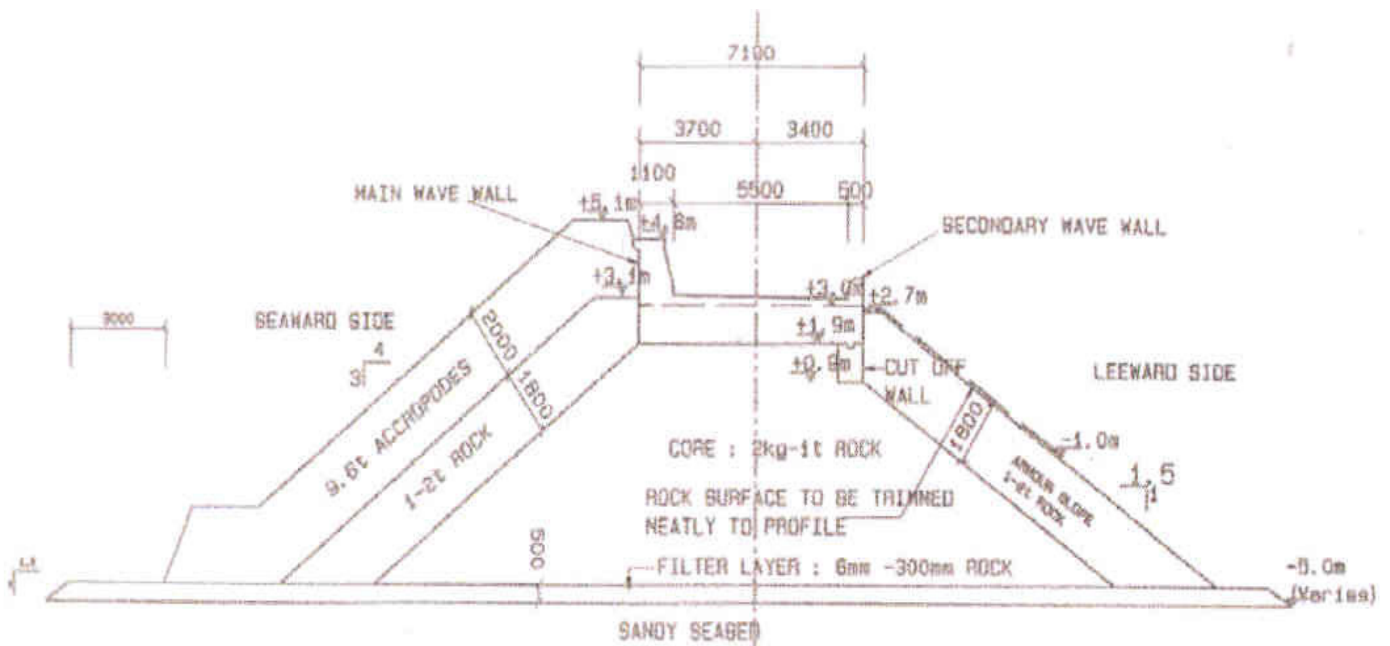
**Figure 1 Design Cross-section of the Club Mykonas Breakwater
(after Bartels et al, 2003)**

This breakwater was constructed in 1988 and was protected by 9.6t Accropodes (see Figure 1). However, by 1991 significant settlements to the armour layer was apparent (up to 3.5m), which included a movement away from the wave wall behind them (up to 1.5m). Surveys revealed that a 3.5m deep erosion hole had developed in 5m of water near to the landward end of the breakwater. The cross-sections for the breakwater shows the 9.5t Accropodes on a 1 in 1.33 slope (3 to 4) with the toe of the units resting on a 0.5m thick filter layer of 6mm to 300mm rock on the sand bed.

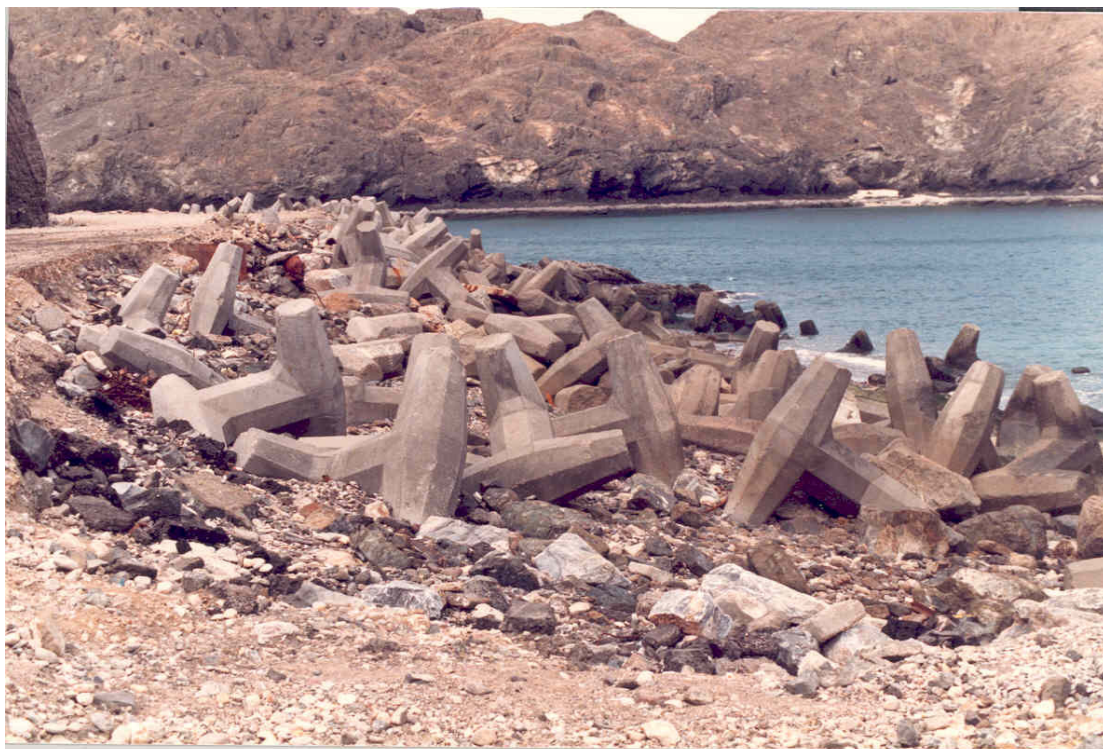
Photograph 1 The Jalali Dolosse revetment after the storm

The damage to the revetment, as can be seen on Photograph 1, was severe and, at the end of the storm, no part of the revetment consisting of two layers of 6t Dolosse units was left undamaged. Again, the storm does not appear to have particularly severe, with a predicted return period of 1 in 25 years, with the structure apparently designed to withstand a 1 in 100 storm.

The reason for the failure was not specifically because of the fragility of the Dolosse units, but the fact that the low crest level of the revetment allowed considerable overtopping, dislodging the Dolosse at the top of the slope, which were not retained in any way. The fact that the Dolosse were sitting on a toe of filter rock weighing on average 1.3kg, undoubtedly also contributed to the failure. For the reconstruction, heavy blocks were placed at the top of the slope and the revetment protected with Shed units, which sat on a concrete toe beam where rock was exposed and a piled concrete beam where the bed was sand. The latter was further protected with a rock armour apron. The heavy concrete blocks placed at the top of the slope were provided with large vents; some 200mm in diameter at 2m centres to resist the uplift forces (see the discussion by Read, 1985).

Lessons: Damage due to overtopping of any rubble mound structure can be severe and can lead to damage to the front face. Reinforcing concrete armour units is not recommended and it is essential to properly design the toe of any structure.

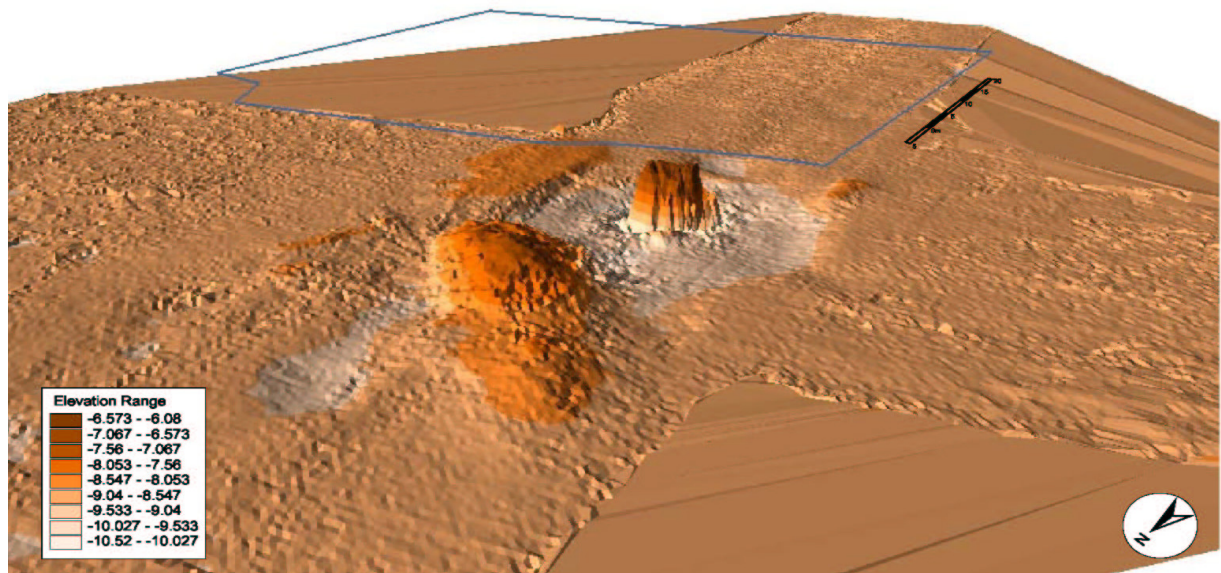
Figure 2 Scour and accretion around the outfall

The failure of scour protection around an 8m diameter offshore outfall diffuser rising some 3m above the bed in a water depth of about 8m below ACD, can also be spectacular, given the right combination of tidal currents and waves (see Figure 2). This particular structure was protected by a 'ring' of scour rock placed as a cone around the structure, with a total placed width of 8m, equivalent to the diameter of the structure ie an inner 3.25m wide ring of 300kg to 1000kg rock, a middle 1.75m ring of 60kg to 300kg rock and an outer 3m ring of filter rock, with each layer resting on the other and the filter layer on the sand bed. It was in theory designed to resist the 1 in 100 year design combination of waves and currents, but was virtually destroyed by a storm which it is believed occurred in November/December 2000. The surface of the apron was lowered by 2m and a pile of rock some 2m high was left downstream of the circular scour hole, which was about twice the diameter of the outfall (see Figure 2).

The scour hole created was elliptical with the erosion being greater on the seaward side than the landward side. It should be noted that there were four ports on the seaward side discharging water at 3m/s at an angle of 20° to the horizontal. There was also accretion on the seaward side but, away from the structure, bed levels changed little.

The analysis of the design indicated that the amplification factor for the currents could be as much as 10, which would have been capable of moving the main armour rock. The area of erosion seen was very much as predicted and, despite the increase in the size of the filter rock during construction, it is unlikely that it would have remained stable. It would appear from subsequent model tests that it was the loss of scour rock both from the bed and through the underlayer rock that triggered the failure, along with the passage of sand through the filter rock. The increased turbulence from the outfall jets also appears to have had an impact as would any problems and difficulties during construction.

Model testing of the storm conditions thought to have lead to the failure also produced damage, but not on the scale seen in nature. The revised design, which was more traditional

with the armour rock extending for about 1.5 times diameter of the outfall, was also tested on the model. Geotextile was also provided.
